Geotechnical Site Visit Report

Project Name: I-90 Hyak to West Snowshed Phase 1B	
Contract No: C7852	Page 1 of 2
Day: Tuesday	Date: October 18, 2011

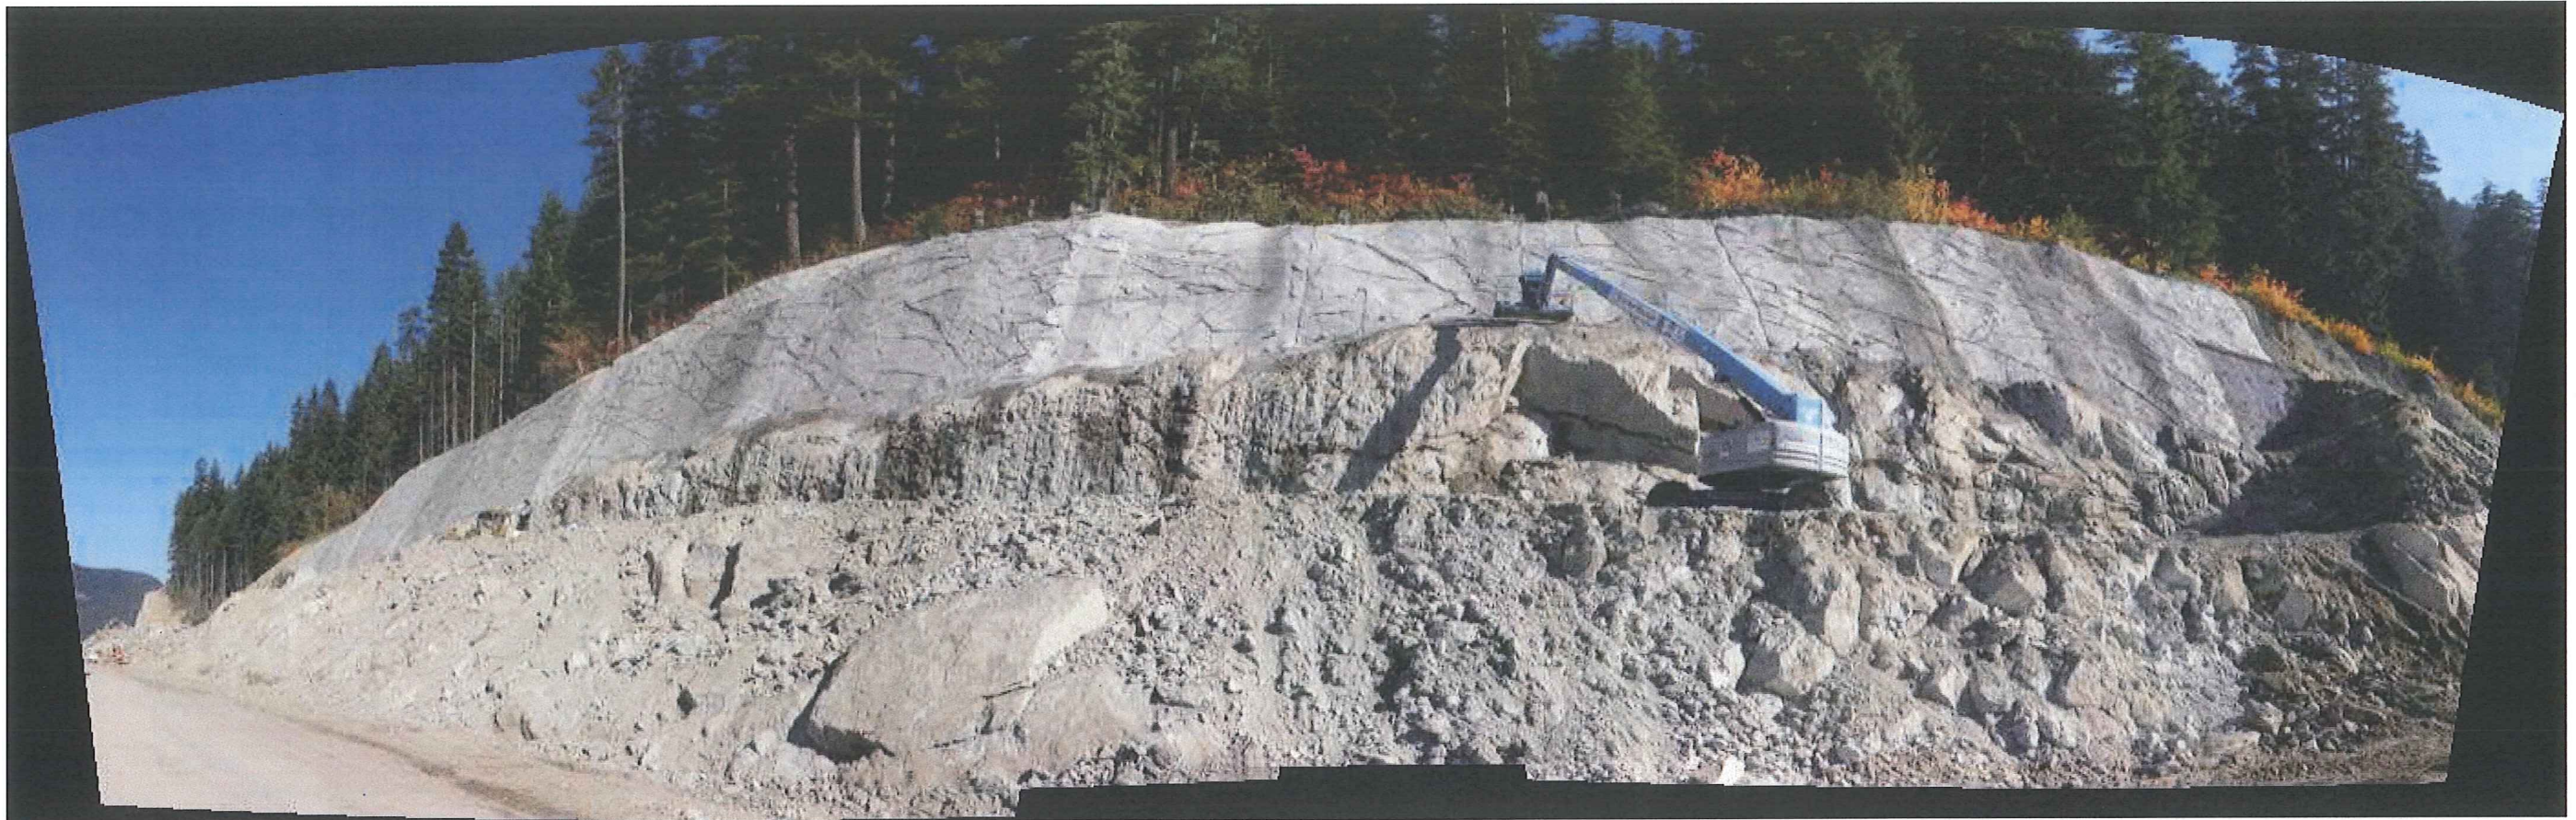
Figure 1. A photograph of the finished, sculptured face of the soil nail wall and the upper portion of the rock cut. The lower portion of the rock cut has yet to be revealed for evaluation, and it appears that the debris won't be removed until next season.

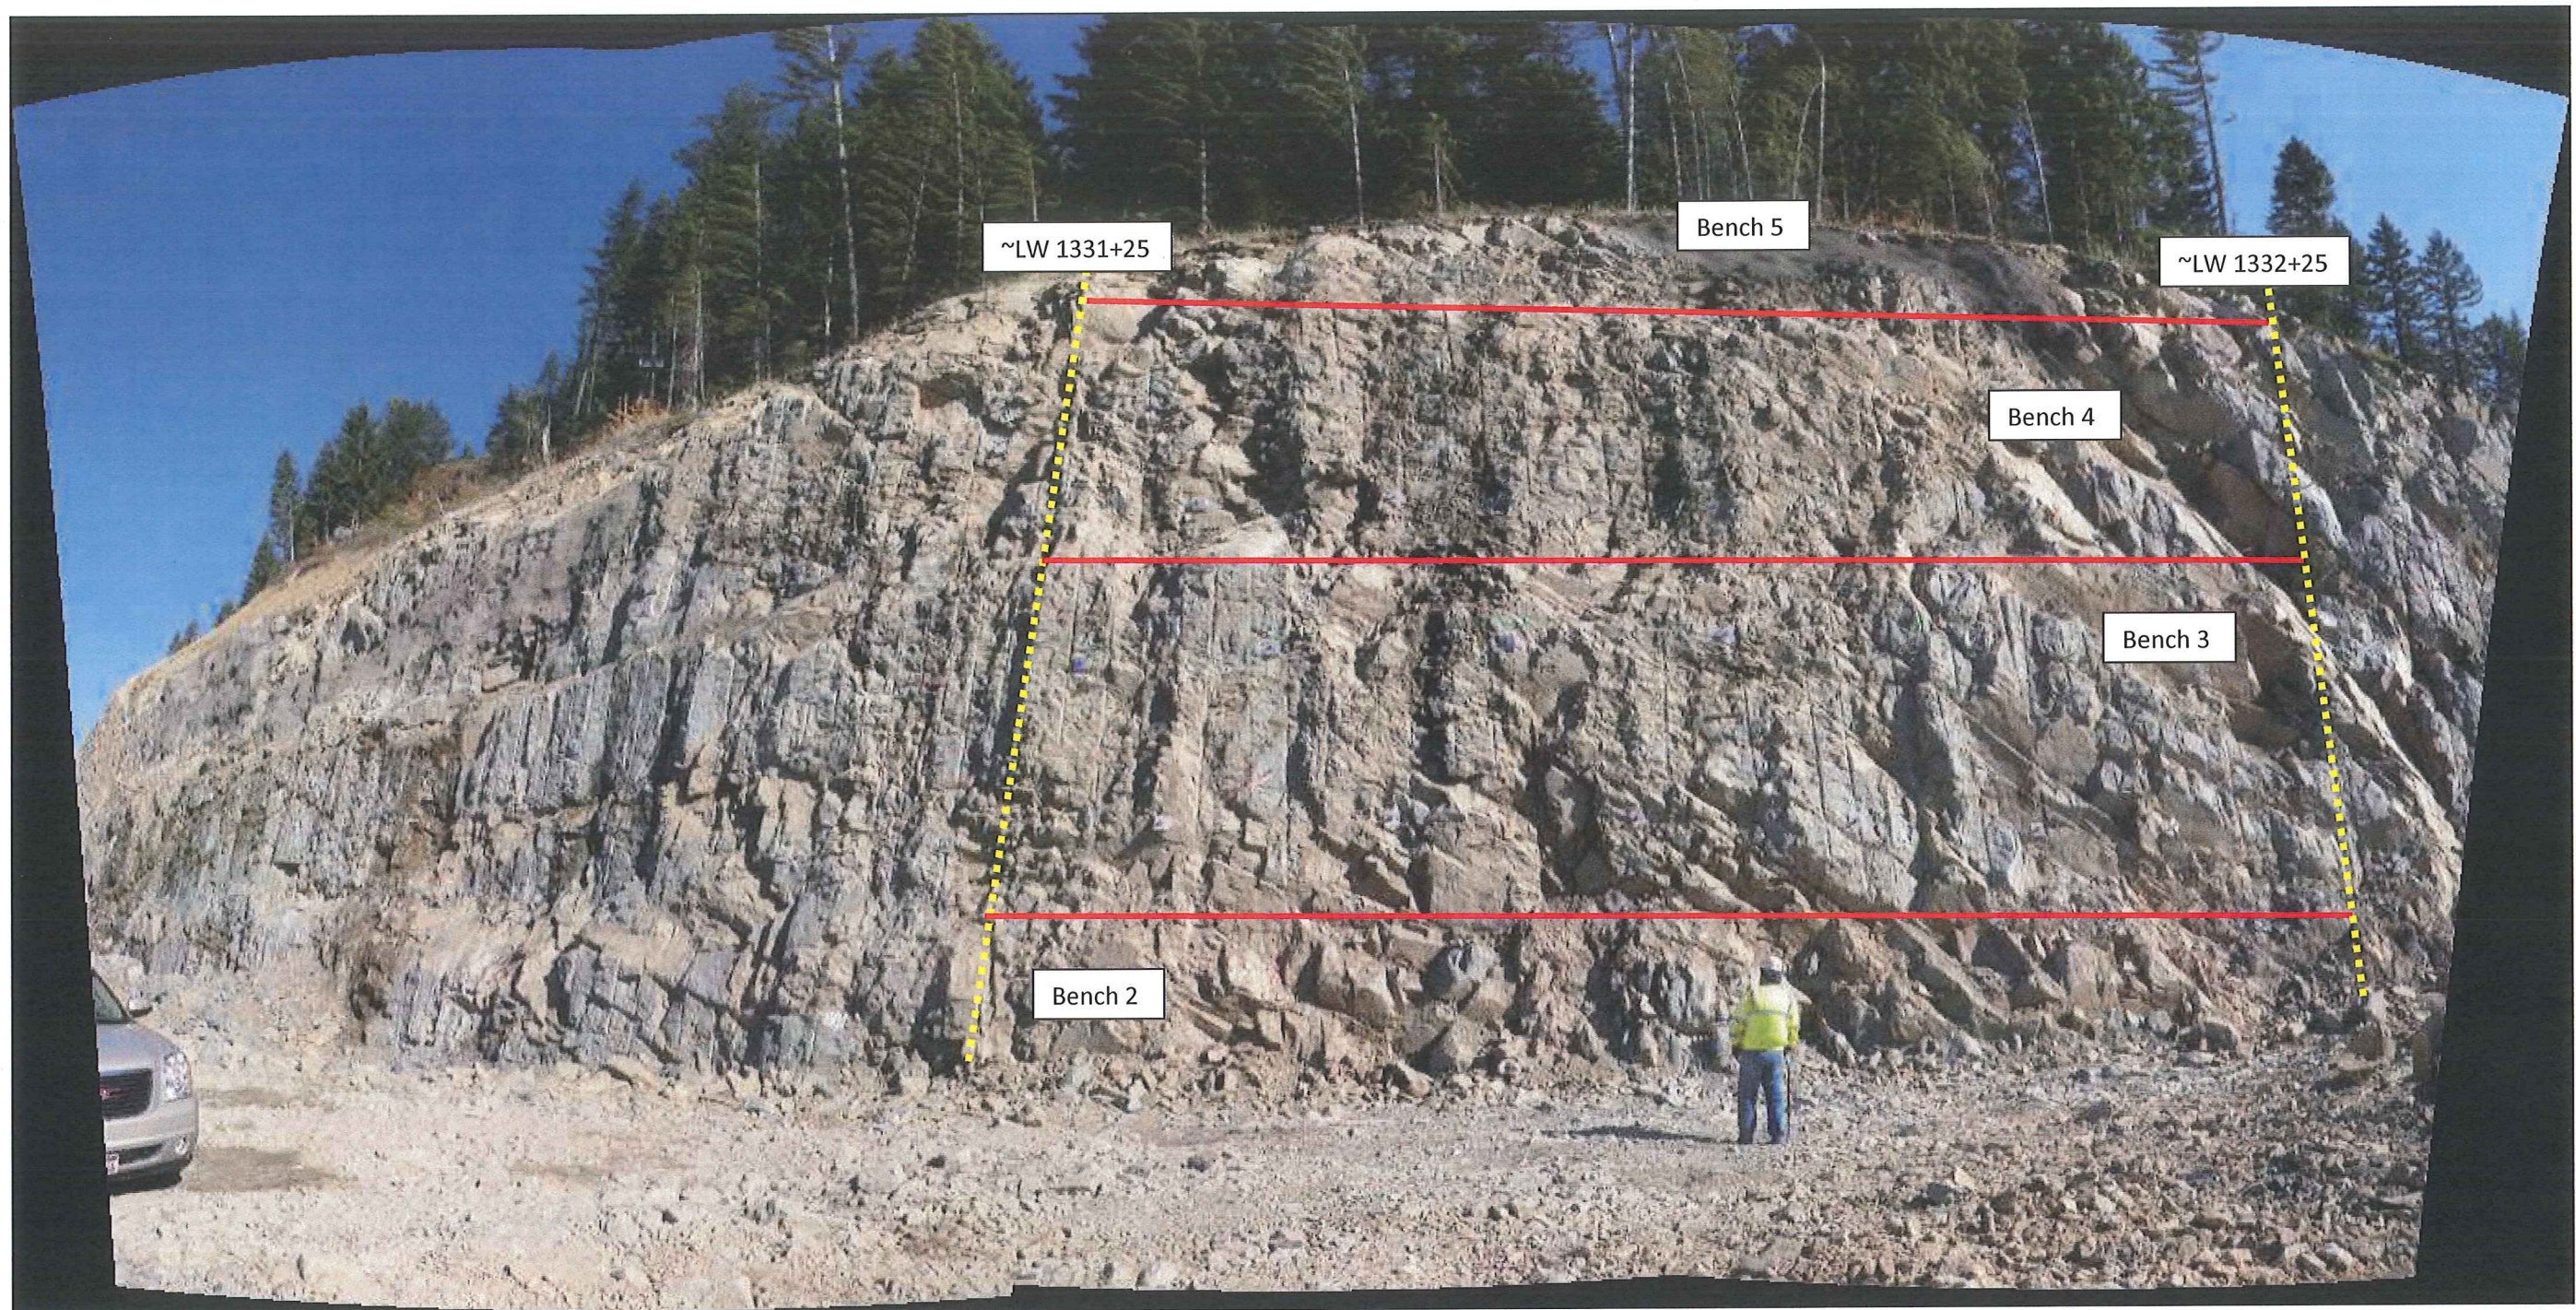
Figure 2. A photograph of the exposed rock cut from approximately LW 1330+50 to 1332+25.

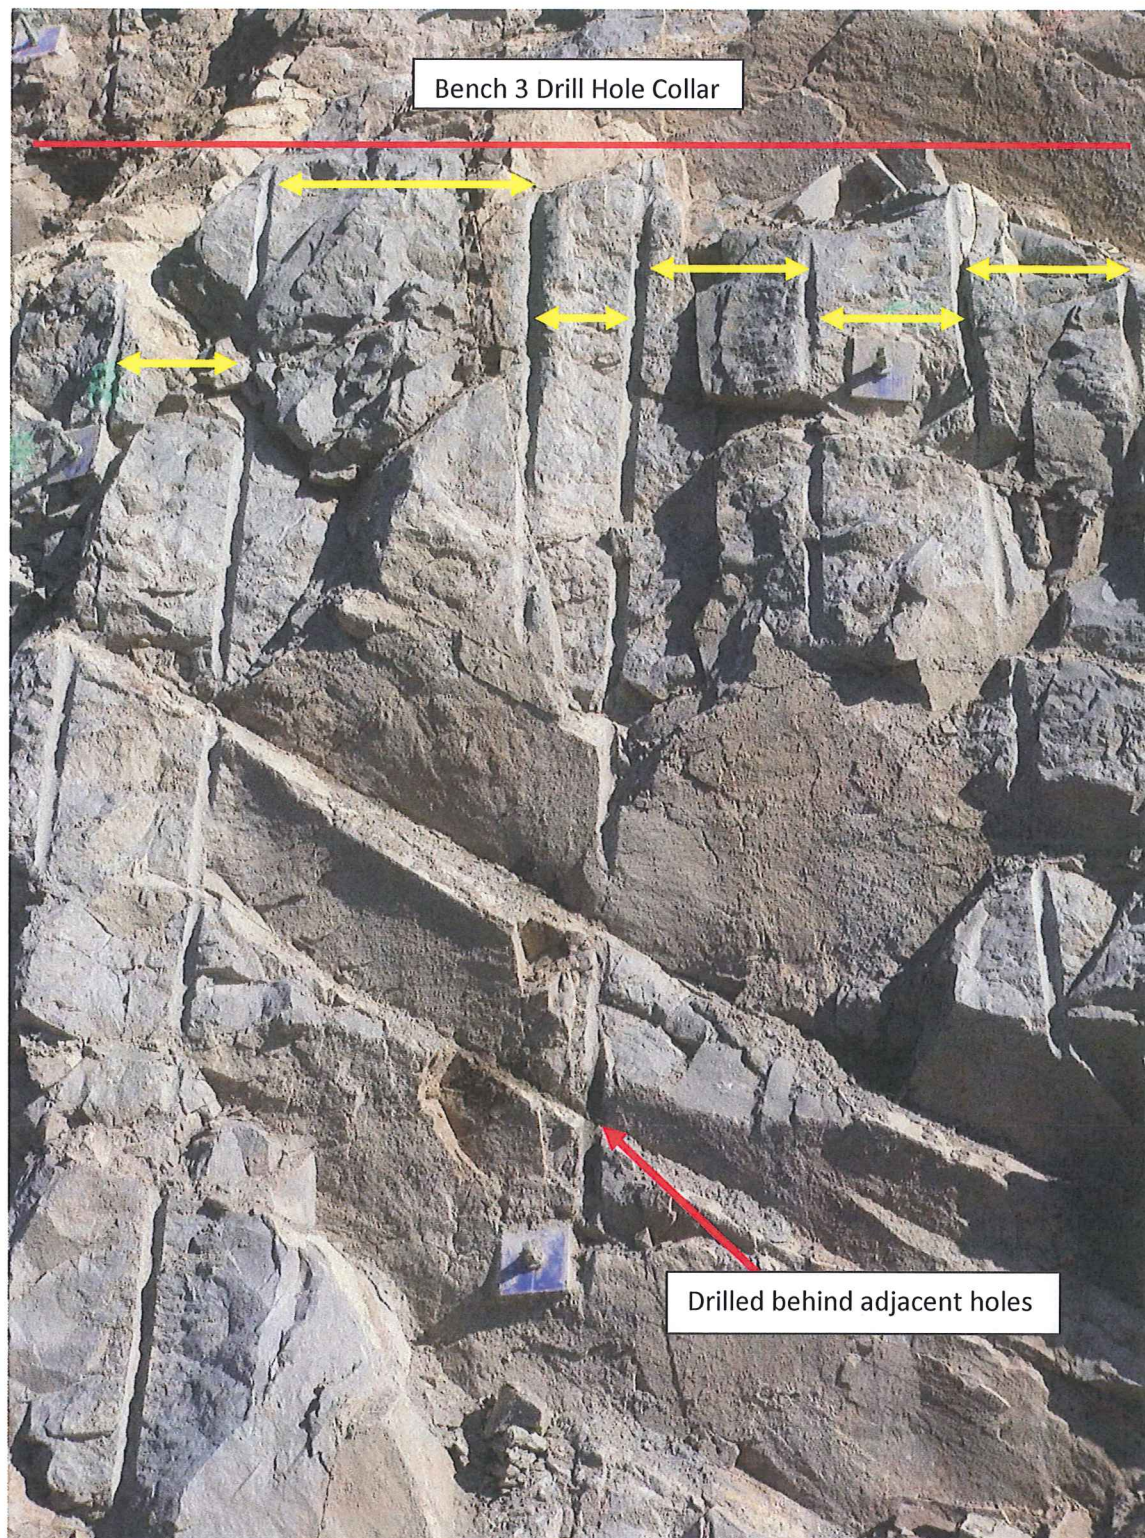
Jerry and my evaluation centered on the section that was accessible from approximately LW Station 1331+25 to 1332+25, where there is less geologic structure that may affect drilling operations. We thought this would be a representative section to evaluate the potentially improved performance of the preshear drilling efforts by Western States on Bench 3 and the upper six feet of Bench 2. As can be seen in Figure 3 and 4, the preshear line drill control issue continues to be a major problem. According to Brad Schut and Erik Warren, there have been considerable deductions for preshear lines for not meeting our deviation specification outlined in Section 2-03.3(2) under Controlled Blasting subsection (d). He estimated that between 25 and 30 percent of the holes are out of deviation when they are finally exposed, several weeks after drilling and blasting. In our opinion, Figure 3 illustrates the uneven spacing of the preshear drill holes at the collar elevation, indicating a total lack of effort, or care, to drill preshear lines at the spacing identified in their blast plan or within deviation specification. Figure 3 clearly indicates to us that the geology and drill equipment are not the problem; taking the time to setup the slope angle and properly space the drill holes is the problem. This blast hole alignment problem is not just a visual issue. The poor drill control of the preshear lines is concentrating explosives in the slope in some places and is limiting explosives needed to make a good preshear line in others. This is why the slope has a corduroy appearance. The poor preshear drilling control is resulting

in blast gases following natural geologic fractures and joints rather than breaking between preshear holes, as intended in our standard specification.

Figure 3. A close-up photograph showing the lack of care during drill hole setup that results in poor control in the preshear face at approximately LW Station 1331+75. Notice the inconsistent horizontal spacing at the drill-hole collar of the bench and the angles of the holes diving behind each other.

- Based on the contractors inability to control preshear holes to a depth of 24 feet the last two seasons, we recommend that lift heights be reduced to 12 feet until the contractor is in compliance with subsection (d) and (f). Specification 2-03.3(2) under Controlled Blasting subsection (f) states that "the length of controlled blast holes for any individual lift shall not exceed 20-feet unless the Contractor can demonstrate to the Engineer the ability to stay within the above tolerances (subsection (d)) and produce a uniform slope. If greater than 5-percent of the presplit holes are misaligned in any one lift, the Contractor shall reduce the height of the lifts until the 9-inch alignment tolerance is met." This will require the contractor to submit new blast plans for the reduced height lifts.

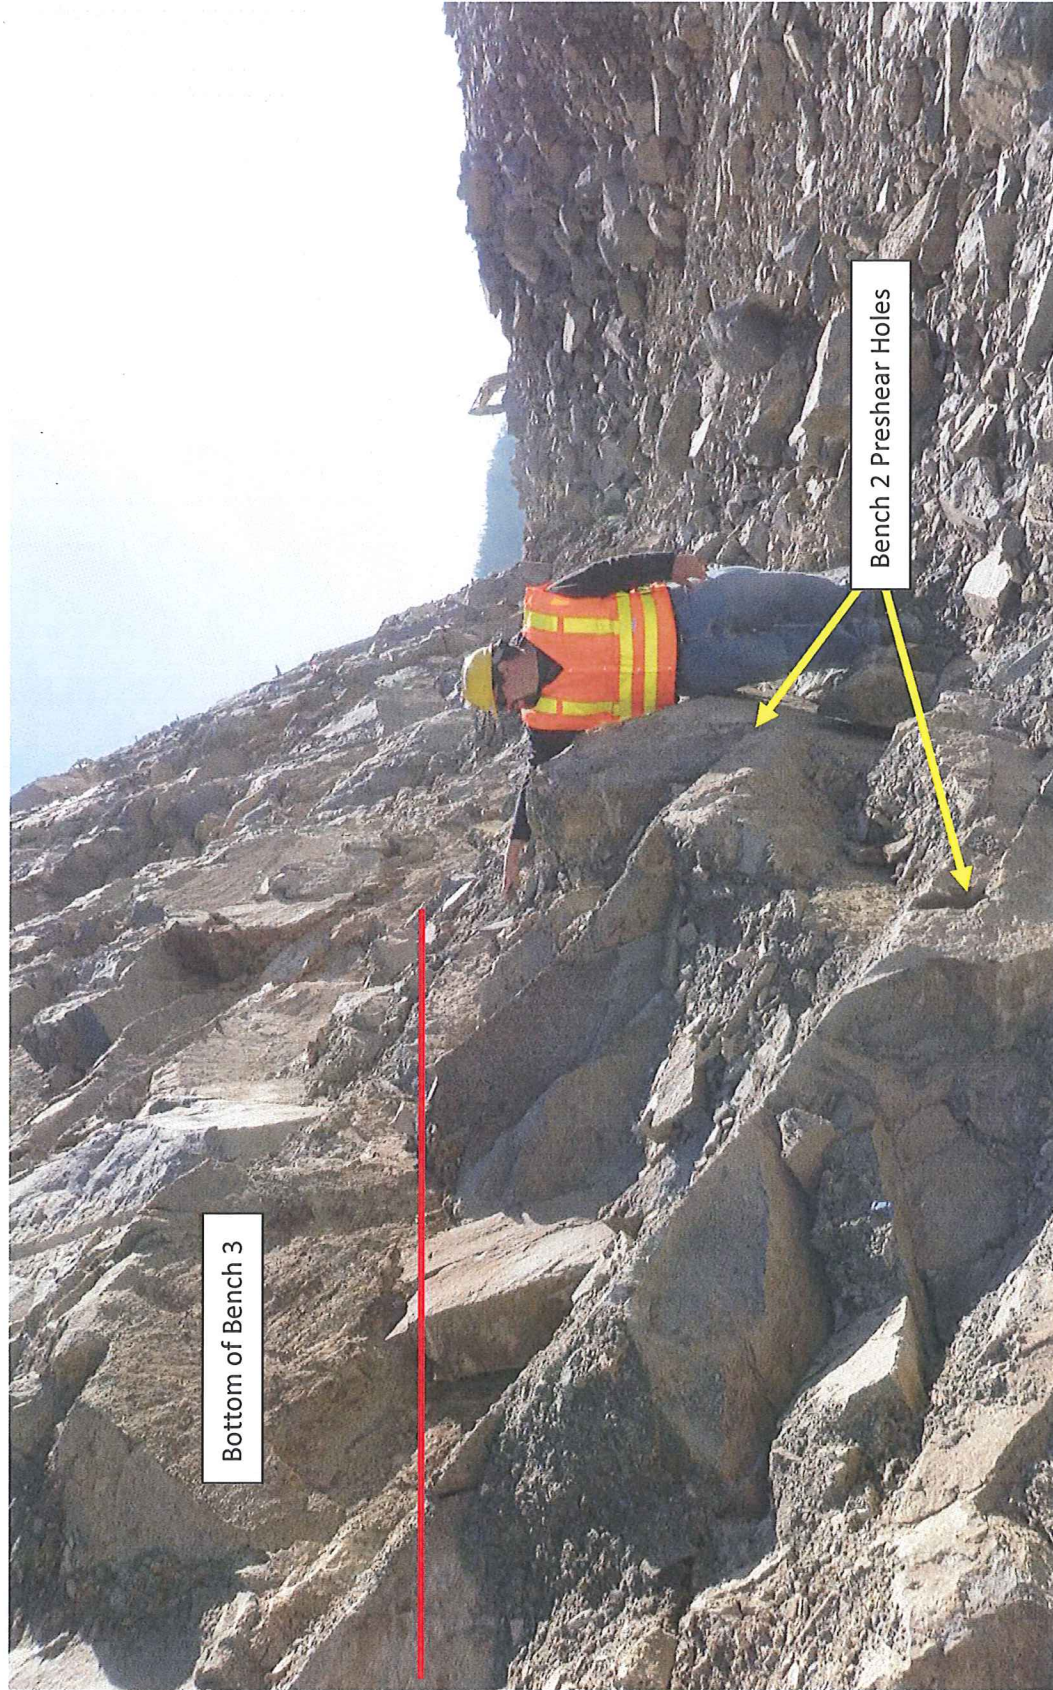
In Figure 4, the large deviations in the preshear lines at the base of the lifts are leaving wide shelves of irregular rock that exceed the maximum of 3 feet, as agreed to in 2010 with the contractor. The irregular bench offset in the LW 1331+75 area is further indication that the preshear holes are not being drilled to our specifications. Although the production blasting has dramatically improved this season, we feel it is unreasonable to let the contractor continue with their preshear drilling when hole alignment control issues are continuing to produce inferior results. We strongly recommend the following contractual enforcement actions be taken by the Region Construction Administration Team for next season:

Figure 4. This photograph shows the unevenness at the bottom of Bench 3 where it transitions to Bench 2. Erik Warren is standing where the surveyors placed the back of bench 2 at the transition. There is approximately 6.5 feet of offset, which further indicates poor drill control.

- Since the contractor has continually demonstrated that they will not remove the muck from the face of the shot before beginning to drill and shoot additional areas, we strongly recommend that test blast sections (subsection (a)) be fully excavated and evaluated prior to commencement of any further drilling until the contractor can meet the specifications outlined in subsection (d) and (f). Without enforcement of this part of the specification, we will have little hope of seeing improvements to the finished rockslope face.
